CISP POSITIVES

(January -February- March 2016)

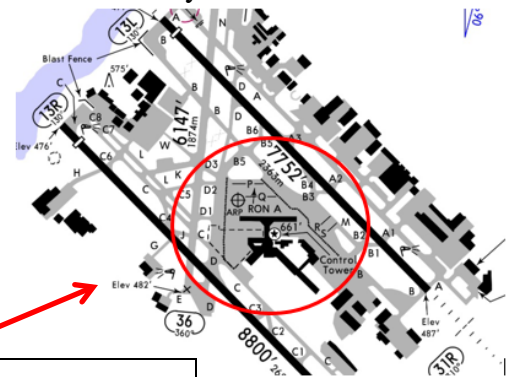
Potential Hazard: An incorrect/confusing taxiway marking on the Jeppesen, or Jepp, Airport Diagram at Dallas Love Field (DAL) may have contributed to crew confusion resulting in taxi deviations. Taxiway “Papa” is a movement area. “Taxilane Quebec” is a non-movement area. Papa & Quebec are side by side. On the Jeppesen chart, “Papa” and “Quebec” are not clearly defined. On the FAA chart, the non-movement area is clearly marked and easily understood.

***Jepp diagram that created confusion with Taxiway P and the Taxi Lane Q in the Non movement area.

Resolution: After receiving the CISP airline, information was sent to Jeppesen DAL Tower does not have access to Jepp aware of the differences. The clarify why there was confusion and misunderstandings regarding taxiway PAPA and why crews tend to miss the taxiway. Jeppesen developed a strategy for addressing the problem at DAL, implemented a new airport diagram, and reviewed the non-movement area depiction in general terms. Jeppesen acknowledged that the initial query from our ATSAP Advisory Team (AAT) CISP analyst was definitely the driving

misunderstandings regarding taxiway PAPA and why crews tend to miss the taxiway. Jeppesen developed a strategy for addressing the problem at DAL, implemented a new airport diagram, and reviewed the non-movement area depiction in general terms. Jeppesen acknowledged that the initial query from our ATSAP Advisory Team (AAT) CISP analyst was definitely the driving

force behind the changes made to the Jeppesen airport chart at KDAL. The information was welcomed and much appreciated!

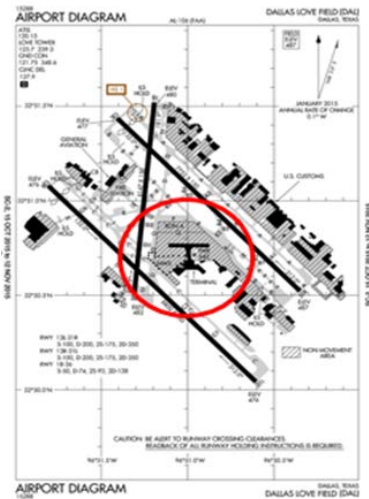
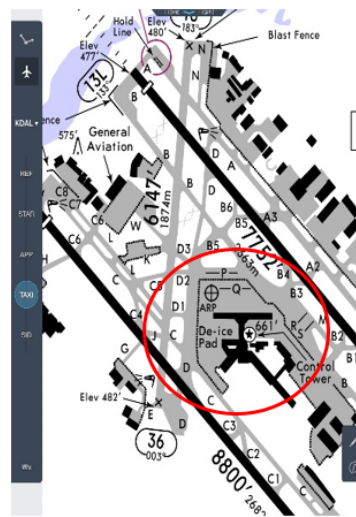
***Revised Jepp Diagram.

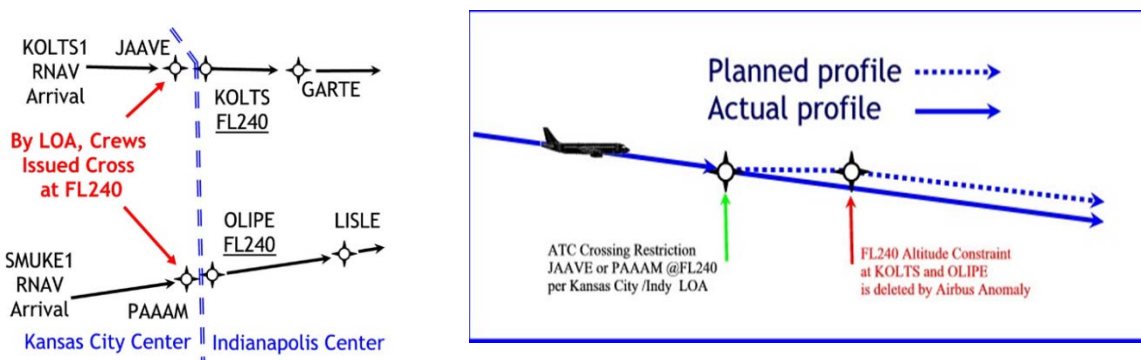
Issue: Altitude Non Conformance with a Clearance Altitude Crossing – Several issues observed with flights descending below crossing restrictions at JAAVE/KOLTS and PAAAM/OLIPE intersections between Kansas City ARTCC (ZKC) and Indianapolis ARTCC (ZID).
Potential Hazard: The Letter of Agreement (LOA) between ZKC and ZID has an ATC crossing restriction at JAAVE or PAAAM @ FL240; however A320-class aircraft were descending below the FL240 Altitude Constraint at KOLTS and OLIPE. Pilot Deviations were becoming an issue as this creates an altitude crossing hazard.

Resolution: This deviation was recognized by an AAT CISP analyst as possibly being related to an Airbus anomaly with older versions of their Flight Management System (FMS) software. After discussions with North American Tech Pilots from CISP airline partners who operate Airbus A320-class aircraft, technical background and information was provided to ZKC and ZID who were developing a new LOA. The information provided clarity and knowledge as to what aircraft were affected and a new LOA was developed to keep arrivals slightly higher--avoiding issues with the older Airbus software.
