CISP POSITIVES

(January -February- March 2016)

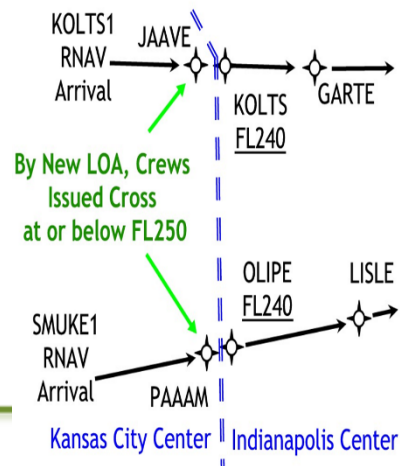
Issue: Altitude Non Conformance with a Clearance Altitude Crossing – Several issues observed with flights descending below crossing restrictions at JAAVE/KOLTS and PAAAM/OLIPE intersections between Kansas City ARTCC (ZKC) and Indianapolis ARTCC (ZID).
Potential Hazard: The Letter of Agreement (LOA) between ZKC and ZID has an ATC crossing restriction at JAAVE or PAAAM @ FL240; however A320-class aircraft were descending below the FL240 Altitude Constraint at KOLTS and OLIPE. Pilot Deviations were becoming an issue as this creates an altitude crossing hazard.

Resolution: This deviation was recognized by an AAT CISP analyst as possibly being related to an Airbus anomaly with older versions of their Flight Management System (FMS) software. After discussions with North American Tech Pilots from CISP airline partners who operate Airbus A320-class aircraft, technical background and information was provided to ZKC and ZID who were developing a new LOA. The information provided clarity and knowledge as to what aircraft were affected and a new LOA was developed to keep arrivals slightly higher--avoiding issues with the older Airbus software.
